Wolverhampton Archaeology Group

Project No 89

The WW2 observation tower at Marsh Park, Brierley Hill and a
brief glimpse at the park's history

Date: January 2025

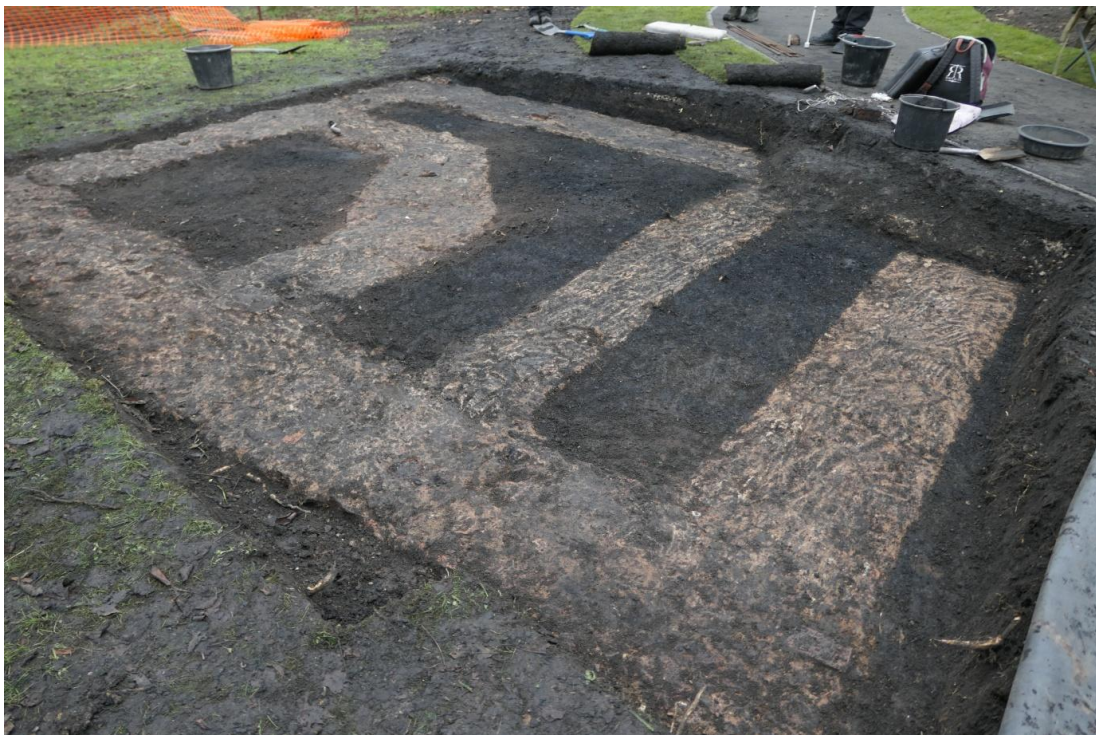
Figure 10. Uncovered foundations made of mortar and brick fragments.

The foundations were constructed from mortar containing brick fragments and were roughly aligned on the long axis N-S, measuring 15 feet x 11 feet (imperial measurement) or 4.5 x 3.35 metres (metric). The depth of the foundation was 6 inches (15 cms) and a width of 2 feet (60 cms). Several brick impressions could be seen in the foundations indicating bricks had been used at some stage in construction but there was virtually no evidence of them in the removed spoil and no evidence of a flooring material that was used inside the construction.

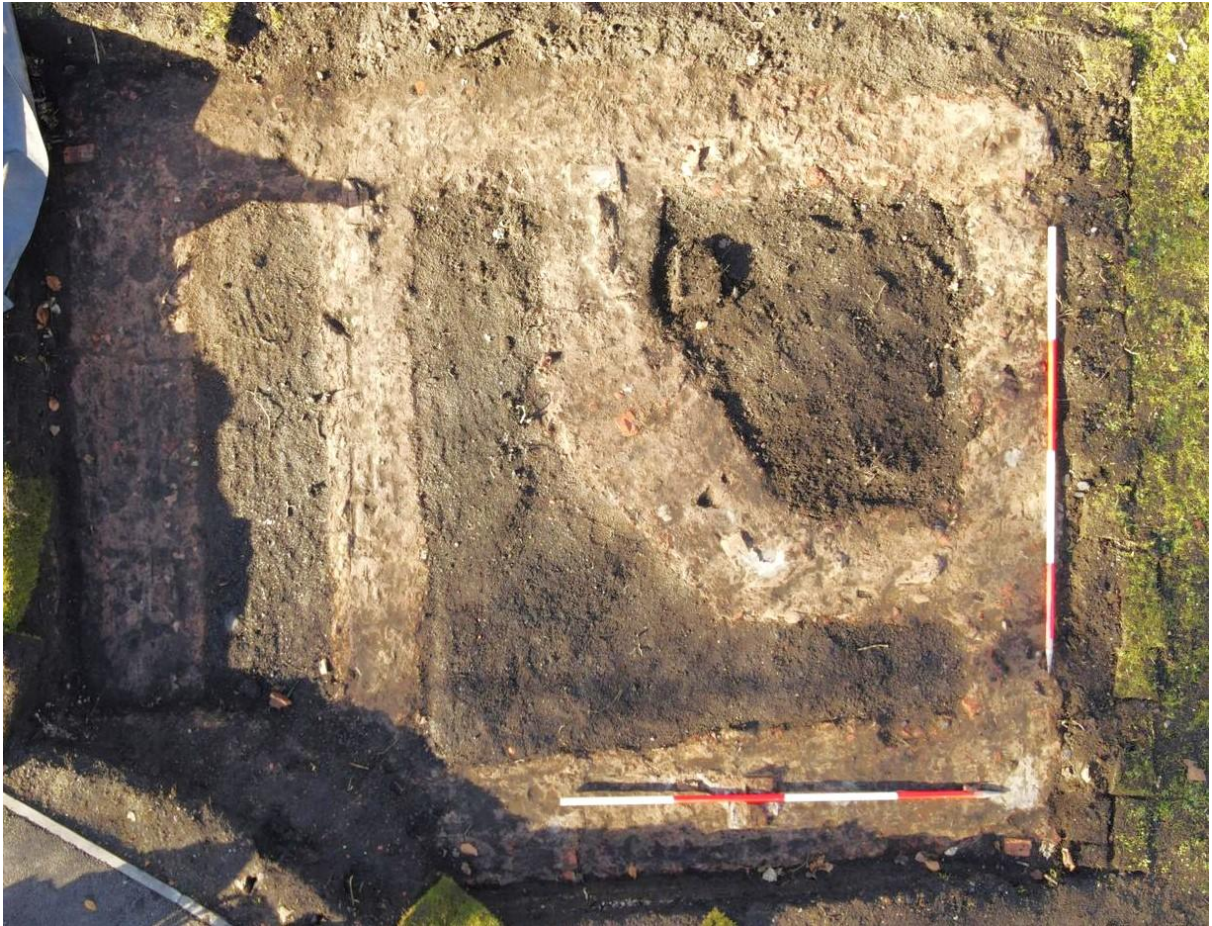
Figure 11. Drone aerial view of foundations (poles are 2 metres). Photo Wayne Little.

The pad was not solid concrete as we might have expected but a series of mortar foundations, 15 cms deep, perhaps telling us where walls had been erected as can be seen from the photos when uncovered. The material used to construct the foundations was a mix of mortar containing brick chunks and fragments and the pad was not solid which may be a sign of someone keeping the cost down and hence not a 'professional' job. As to what the walls were made of we do not know, except there are brick imprints in the mortar base so the lower part of the construction may have been brick and the upper parts reinforced concrete sheets. What was apparent from digging the site is that there was virtually no sign of brick or brick fragments in the spoil, nor for that matter building materials such as wood, tile, concrete or iron work. What we did find however were several copper alloy bolts which might have been used for fixing the reinforced concrete sheets and some rusty iron brackets. (See *figures 24 and 22*).

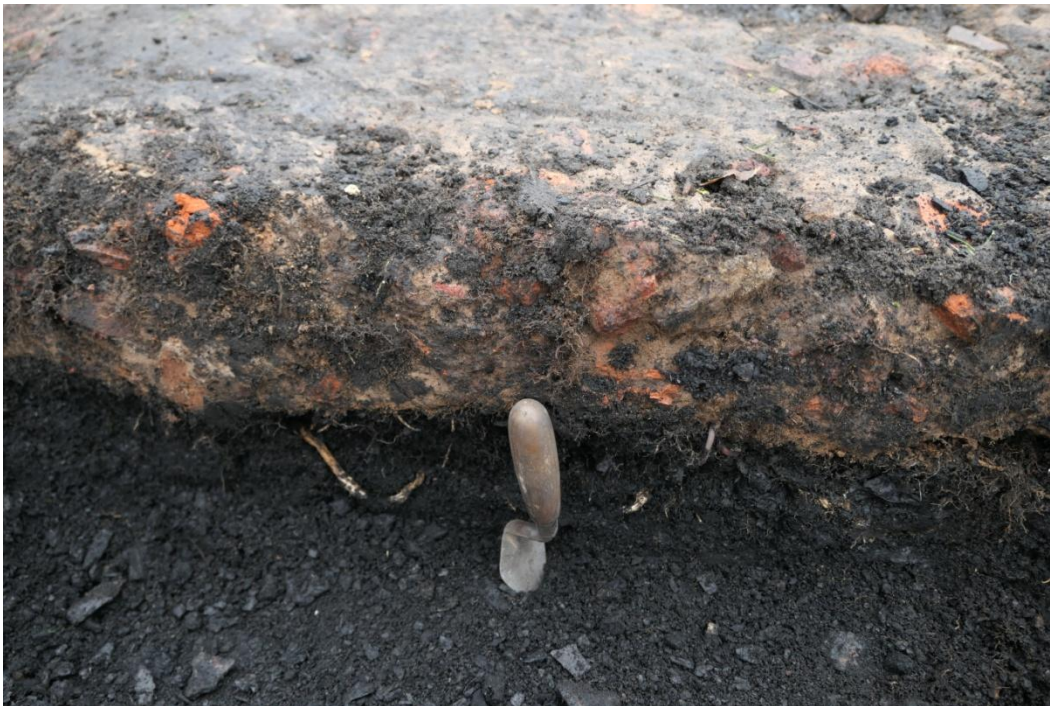
Figure 12. Edge of foundation showing coal debris below.

A sondage was dug next to the foundation edge (inside and outside the structure) in two places to a depth of 40 cms confirming the 'soil' was black and consisted of coal waste, ash and clinker.

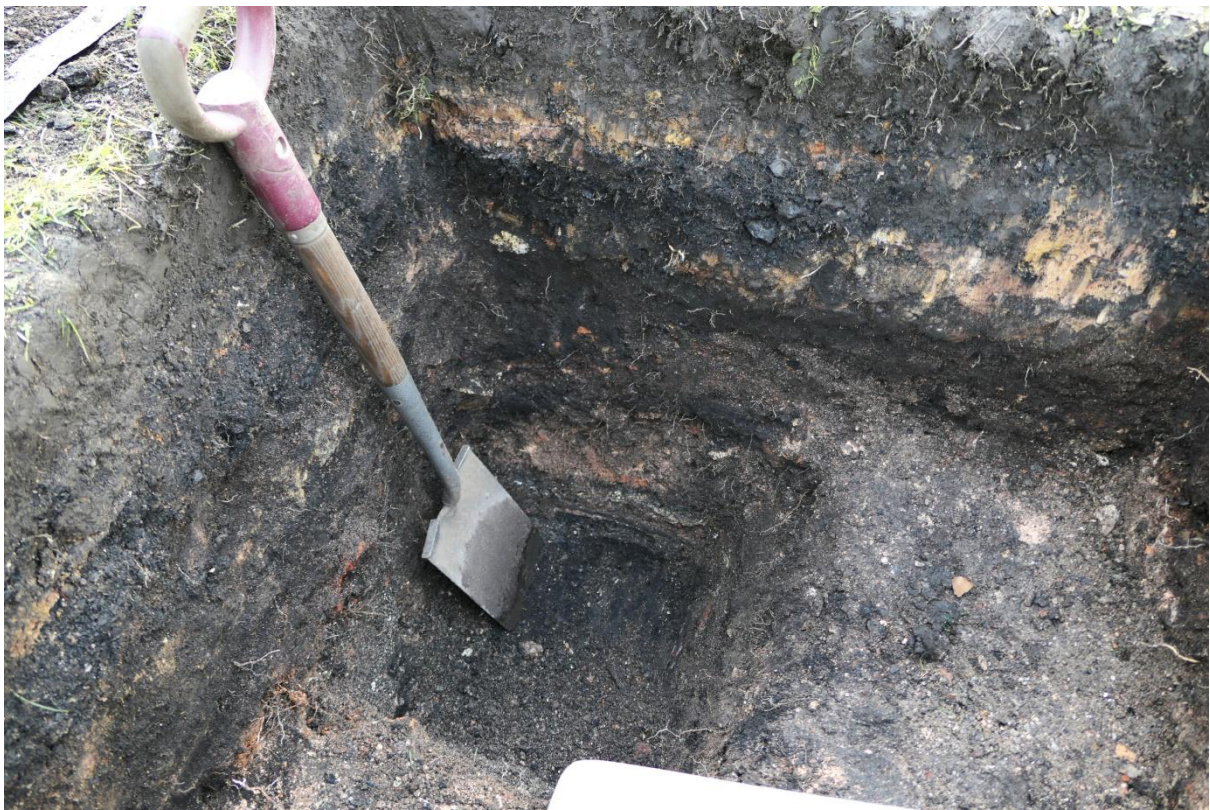
Figure 14. Sondage at SW corner of test pit, one metre deep showing all the alternating waste layers and the orange construction/demolition layer of foundation wall.

A sondage was dug on the SW corner of the test pit as time was running short and this showed multiple alternating layers of coal, ash and clay just going deeper and deeper into the pit showing this was all waste materials from the old mining processes. The foundation wall itself was built on a levelling layer of black material. The digging of the sondage stopped at one metre depth.

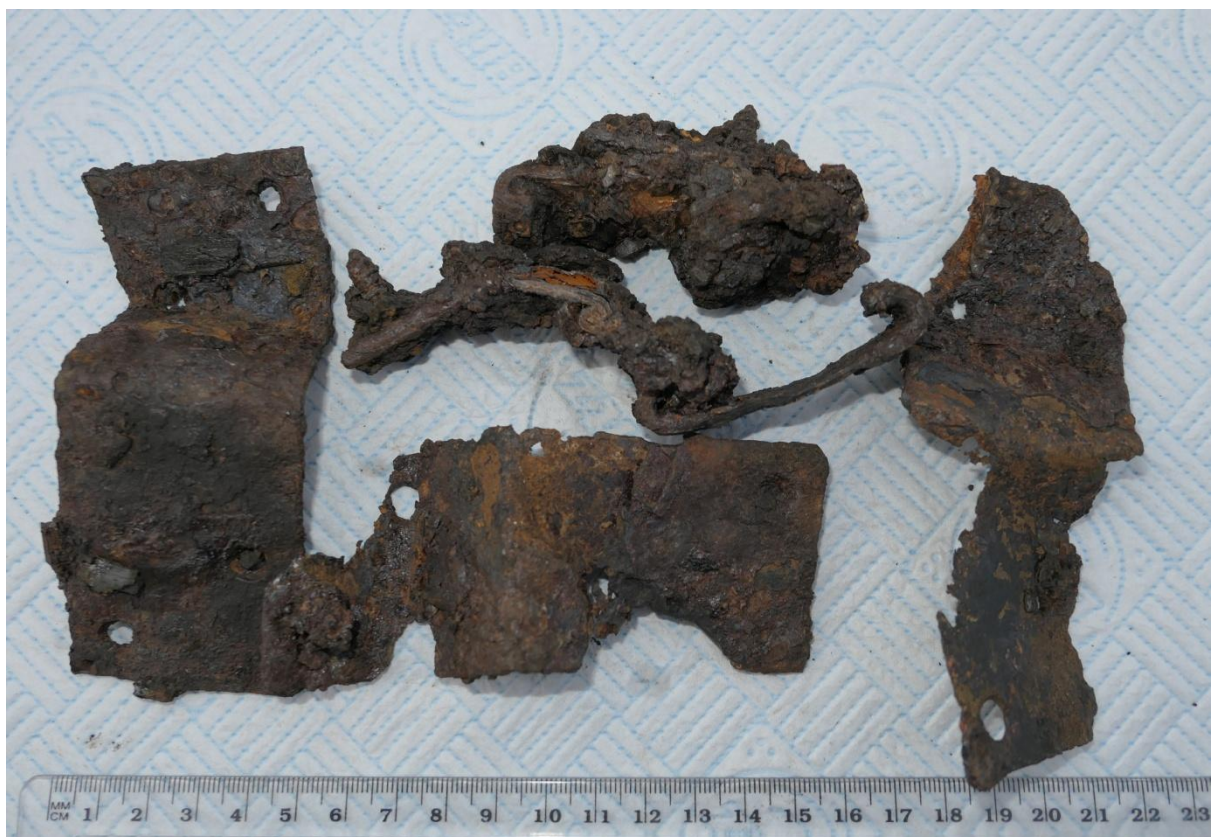
Figure 22. Metal brackets and fasteners.

With reference to the excavation, the main finds that were relevant to the observation tower were probably the copper alloy bolts (*figure 24*), the metal brackets (*figure 22*) and maybe the nails (*figure 23*).

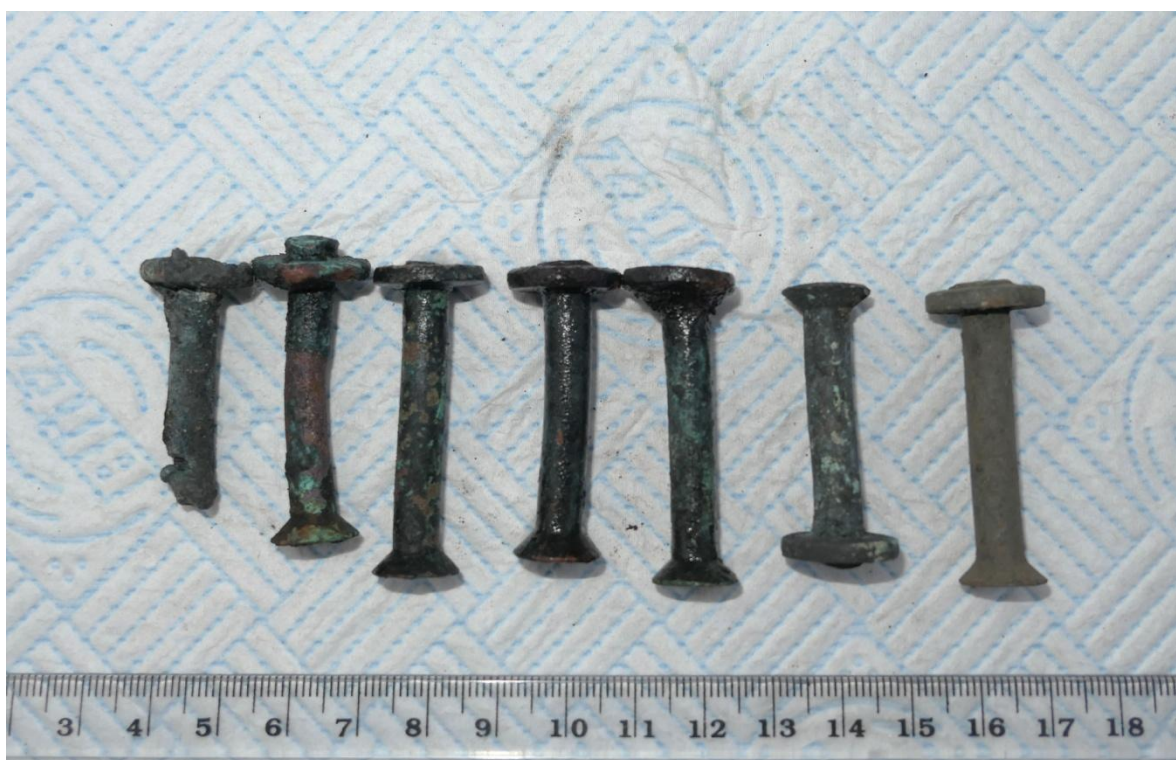
Figure 24. Copper alloy bolts.

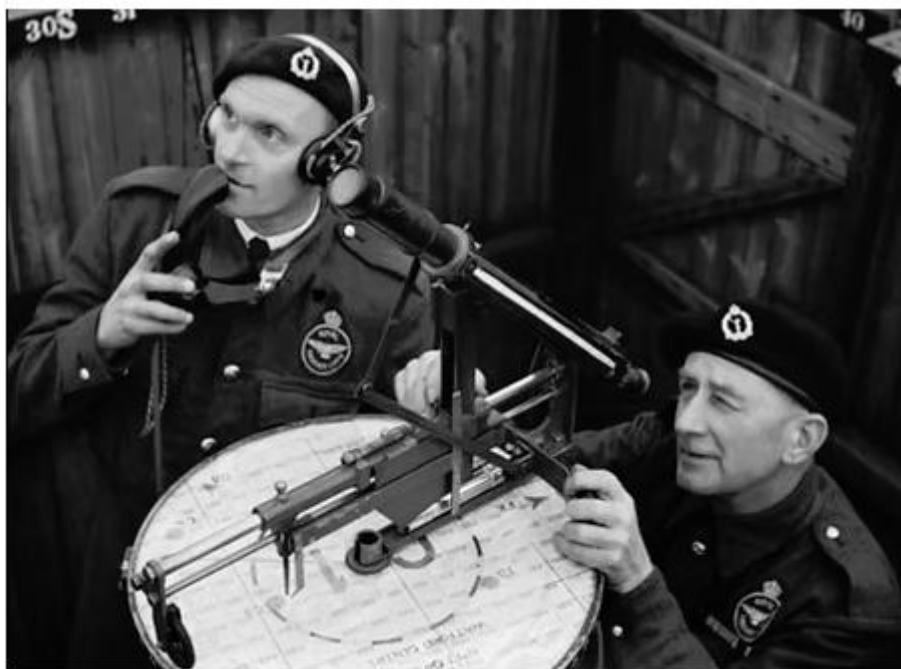
Figure 36. ROC using standard optical sighting system (courtesy of Wikipedia).

As we are aware, radar existed and was used in WW2 by British forces however it was not sophisticated enough to be very accurate and really only worked by picking up planes as they approached the shores so it was vital the planes could be tracked across the country and height, numbers, direction and position were recorded and passed on to the HQ units.

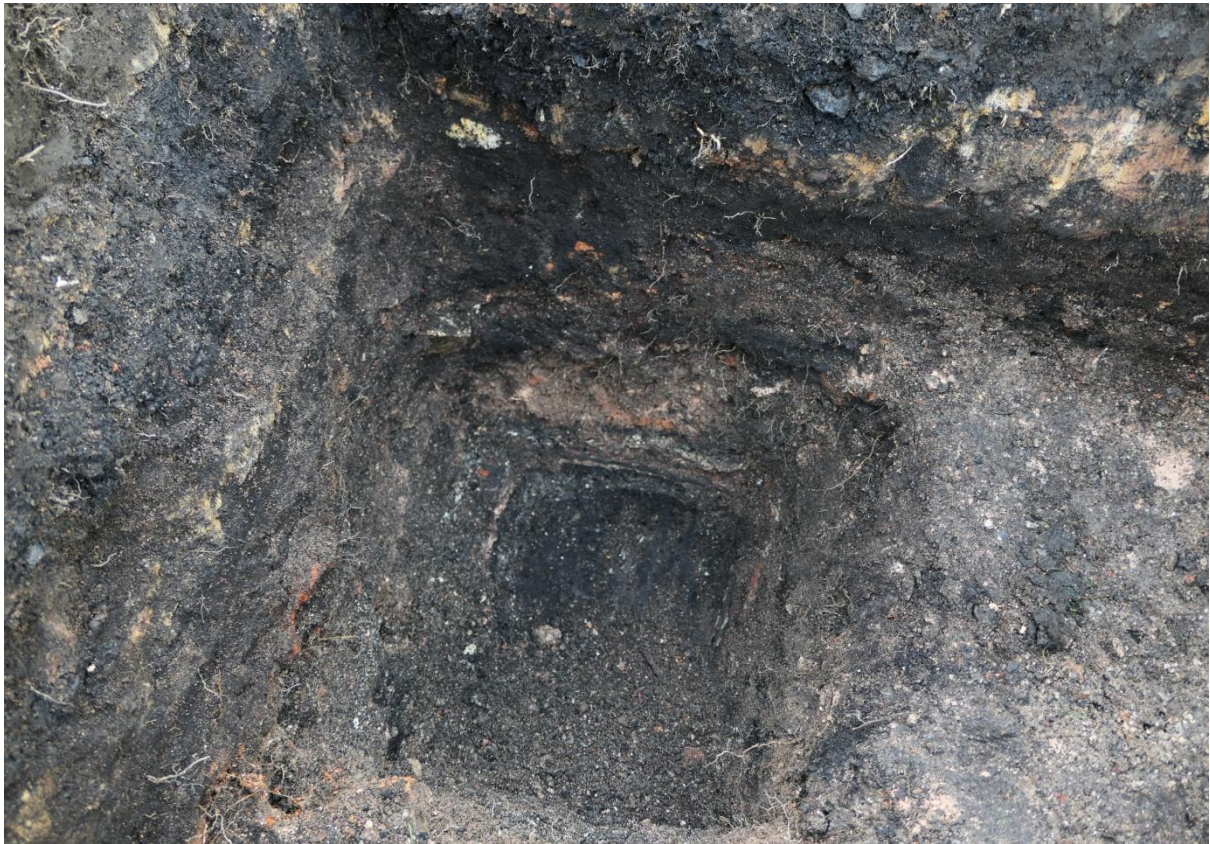
Figure 37. Multiple layers of waste above and below the orangey building layer.

What was the building doing on this site of built up mining waste? Looking further down in the test pit it shows the structure was constructed on a layer of black material, probably a levelling layer, whilst mining was in progress on site as can be witnessed by all the alternating waste layers below the foundation. It was constructed of at least two types of brick, probably from the late 18th century through into the 19th century and it also appears that some mining work continued after the building was demolished as can be seen by the clay, ash and coal in the layers above the structure. The orangey layer in the image (*figure37*) indicates the construction and demolition period of the building.
